The Effect of Weld Penetration on Blast Performance of Welded Panels

Maritime Division
Defence Science and Technology Organisation

DSTO-TR-3017

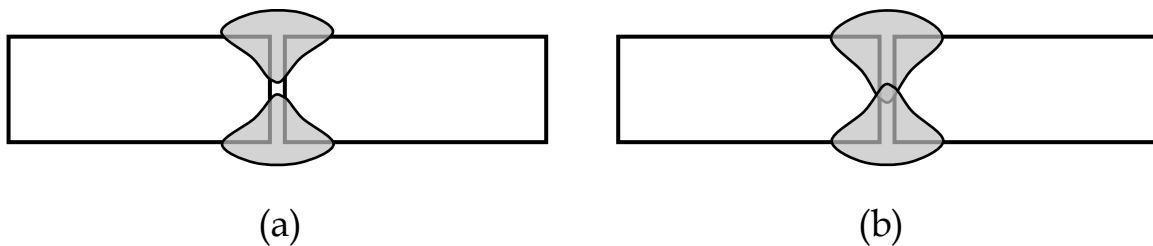
Figure 1: (a) A partial-penetration and (b) a full-penetration butt weld

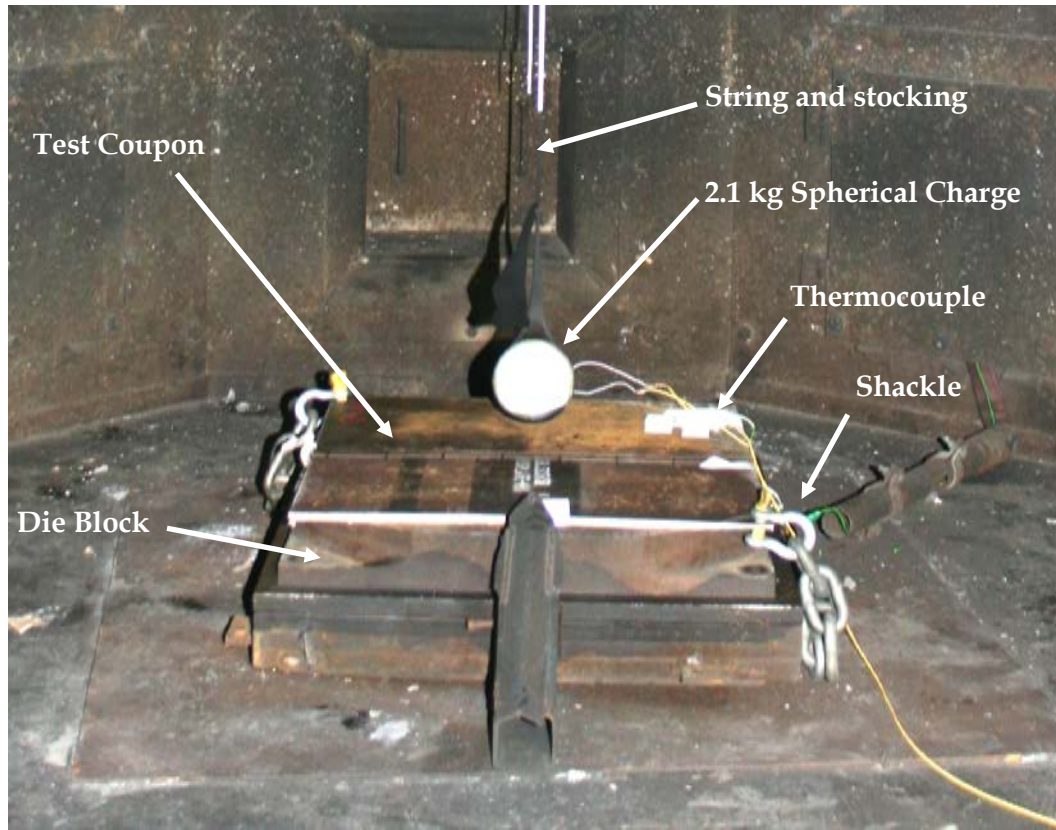
Figure 3: Experimental set-up in Blast Chamber

Tests were conducted in the 3 kg Explosion Chamber at the High Explosives Firing Complex (HEFC) at DSTO's Edinburgh site. A photograph of the test setup is shown in Figure 3.

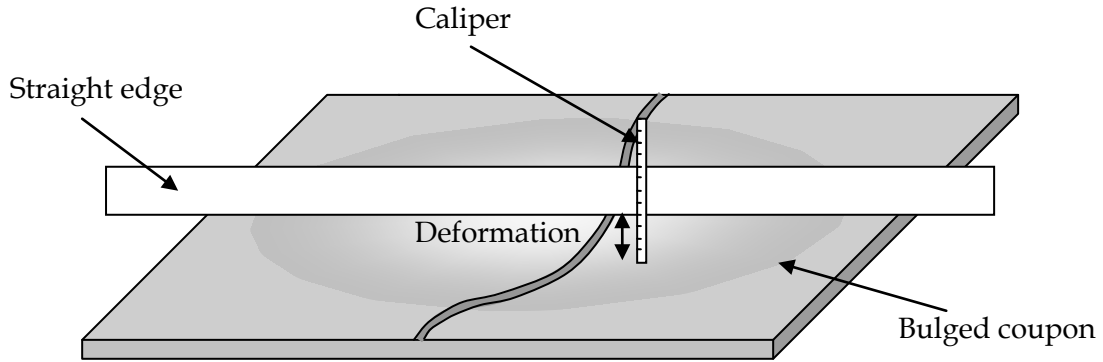
Figure 5: Method for measuring coupon deformation

Thinning of the coupons as a result of the blast was measured using an OLYMPUS Panametrics – NDTTM MG2-DL Ultrasonic Thickness Gauge. Nine measurements were taken as close as possible to the centre of the bulge and these were compared to six measurements taken at the periphery of the plate.

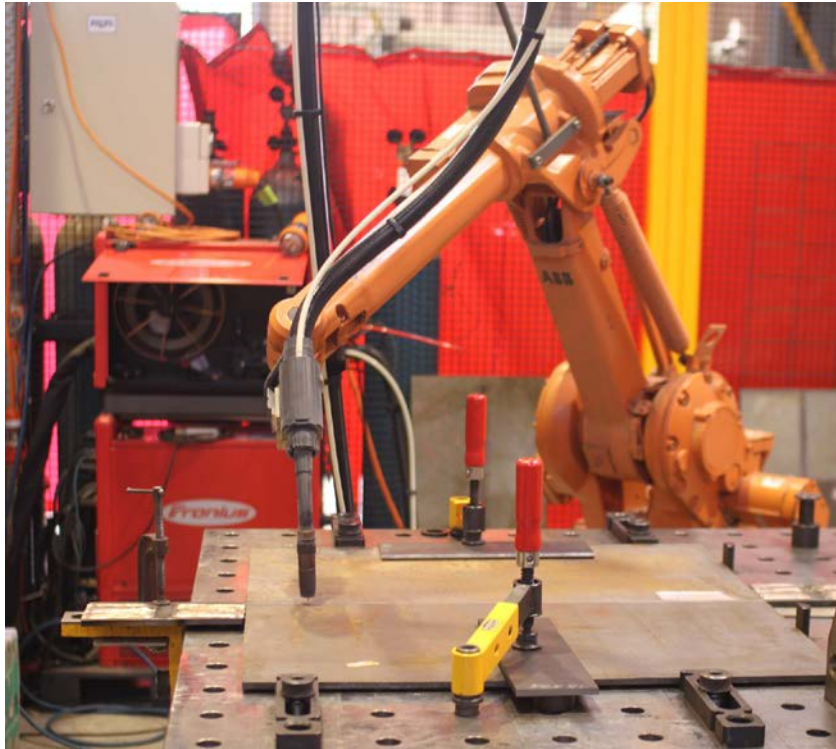
Figure 6: ABB robot and TransPuls Synergic 5000 CMT machine in position to conduct welding operation

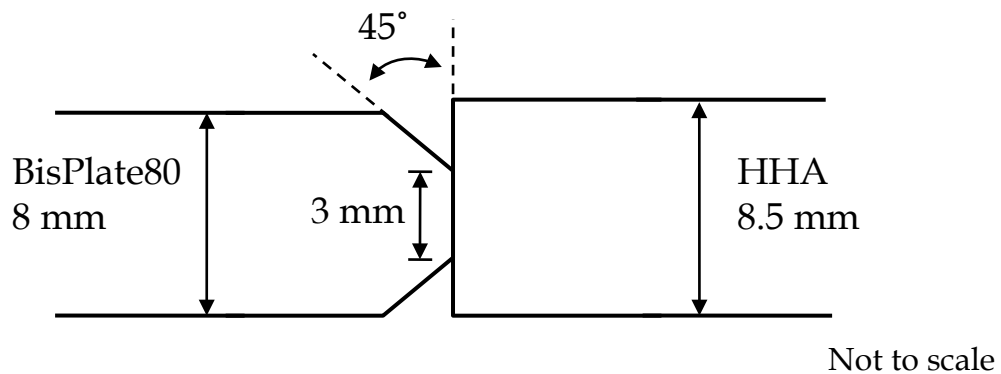
Figure 7: Edge preparation for GMA welding process

Consumable:	1.2 mm diameter TETRA S 20 9 3-G
Shielding gas:	Argon
Preheat:	None
Run off/ run on plates:	Yes
Edge Preparation:	double bevel-groove and tee edge (bevel on the BisPlate80)

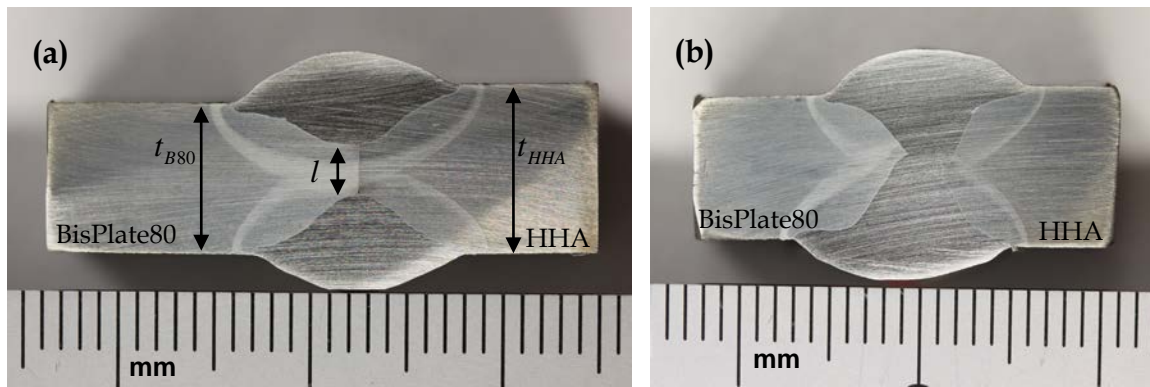
Figure 8: Micrographs showing (a) the partial (~70%) penetration weld and (b) the full (100%) penetration weld, where t_{B80} , t_{HHA} and l are the thickness of the BisPlate80, BisPlate HHA and the un-fused portion of the edge, respectively.

A total of 25 coupons were welded, 15 with parameters to achieve partial (approximately 70%) penetration and 10 with welding parameters to achieve full (100%) penetration. The welding parameters are listed in Table 4 and micrographs of the two weld conditions are shown in Figure 8. The estimated heat input is approximately 800 J/mm for the full-penetration condition and 780 J/mm for the partial-penetration condition.

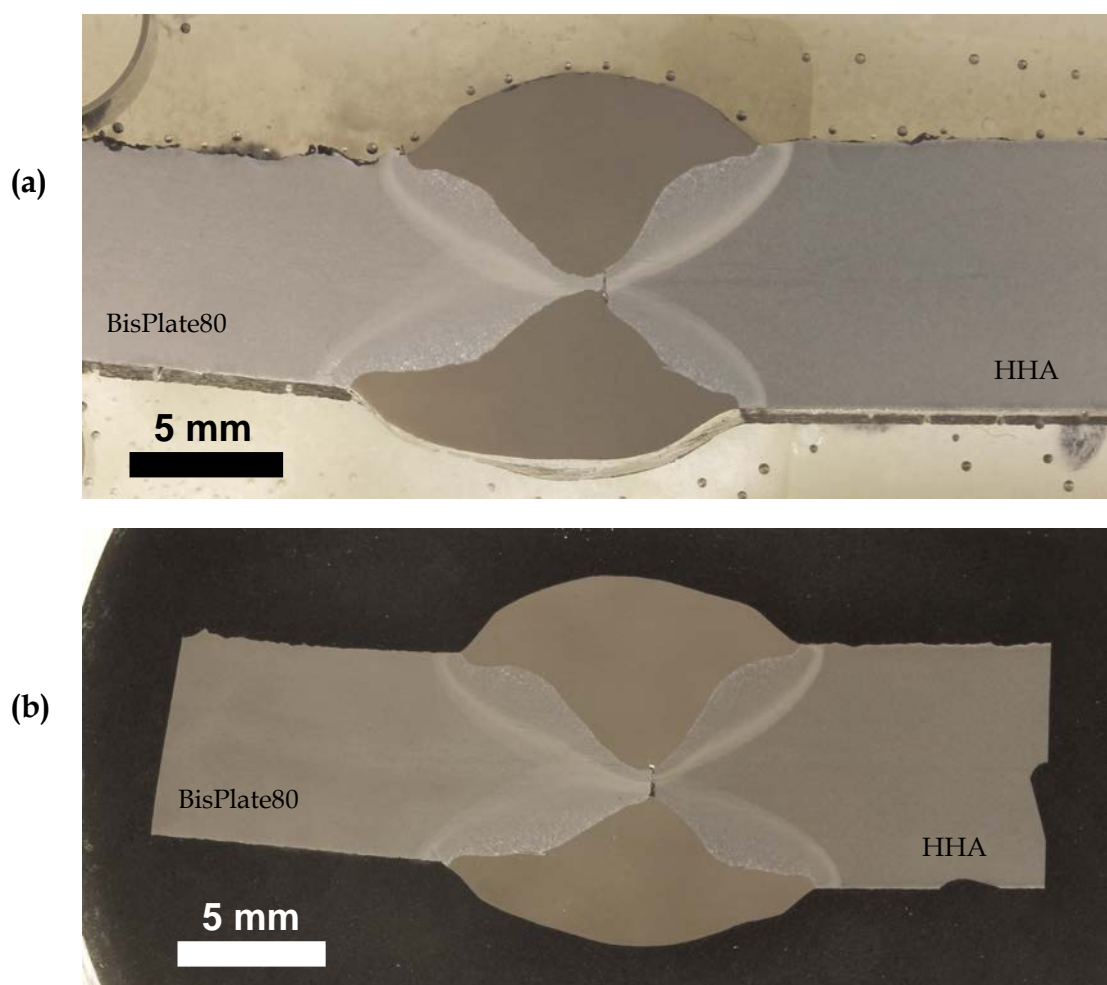
Figure 9: Polished and etched section of coupon labelled (a) 100-02 and (b) 100-04 showing less pronounced partial-penetration (~90% penetration).

Coupons 100-02 and 100-04 represent a less severe incomplete penetration condition than the specified partial-penetration coupons. The metallographic sections in Figure 9, taken after testing, show that the size of the incomplete penetration in the through thickness direction is approximately 1 mm, or a 90% penetration condition, for both coupons. These two plates were set aside until testing had established the threshold stand-off distance below which the full-penetration coupons exhibited cracking. Coupons 100-02 and 100-04 were then tested at that threshold stand-off distance in order to investigate the effect of threshold loading on a less severe incomplete penetration condition.

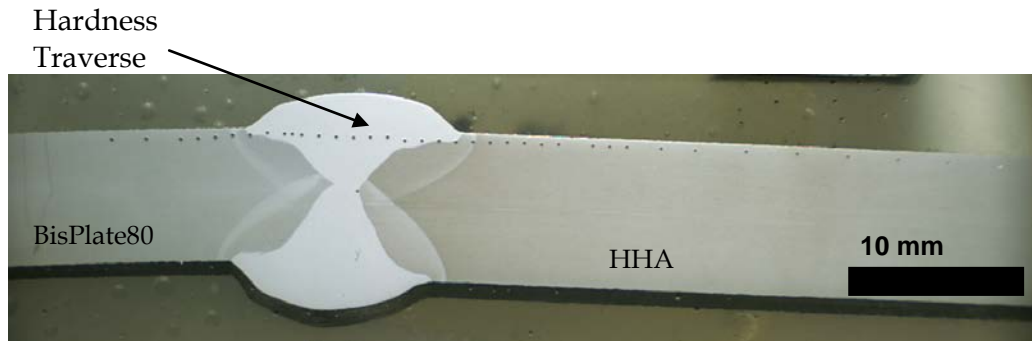
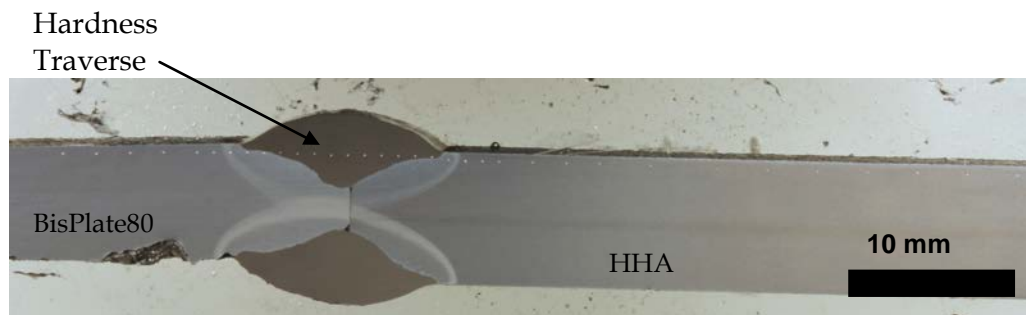
Figure 10: Hardness traverse across a section of (a) a full-penetration test coupon and (b) a partial-penetration test coupon.

A hardness traverse was performed across a mounted and polished section of both a partial-penetration and a full-penetration coupon. A Vickers hardness indenter with a 10 kg load was used for the hardness tests. The traverse was taken approximately 500 μm from the plate surface through the first pass, as shown in Figure 10 for the full-penetration coupon. These results have been plotted in Figure 11.

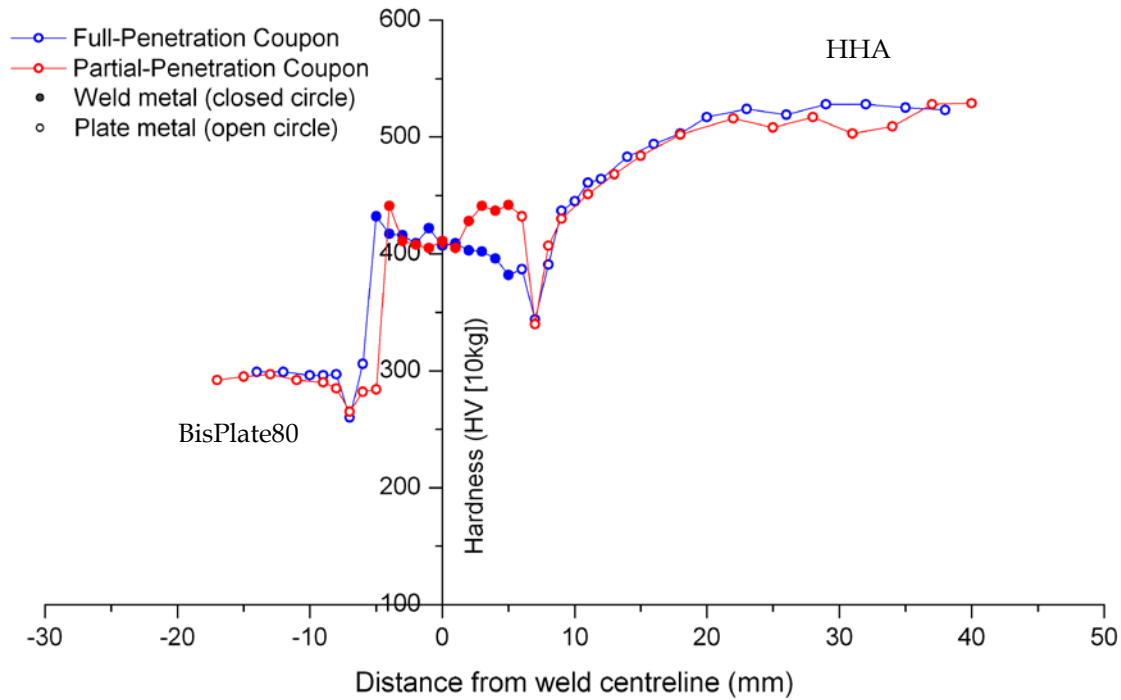
Figure 11: Hardness traverse across a partial-penetration (70%) and a full-penetration (100%) coupon.

The hardness traverses plotted in Figure 11 show that the weld hardness profile of the test coupons is reasonably consistent between the two welding conditions. The measured hardness of the weld material ranged between 382HV and 442HV.

The BisPlate80 HAZ extends approximately 4 to 6 mm from the fusion boundary, beyond which the BisPlate80 hardness values plateau at approximately 300HV. The hardness traverse values progressing from the fusion boundary into the BisPlate HHA plateau at approximately 520HV approximately 20 mm from the fusion boundary.

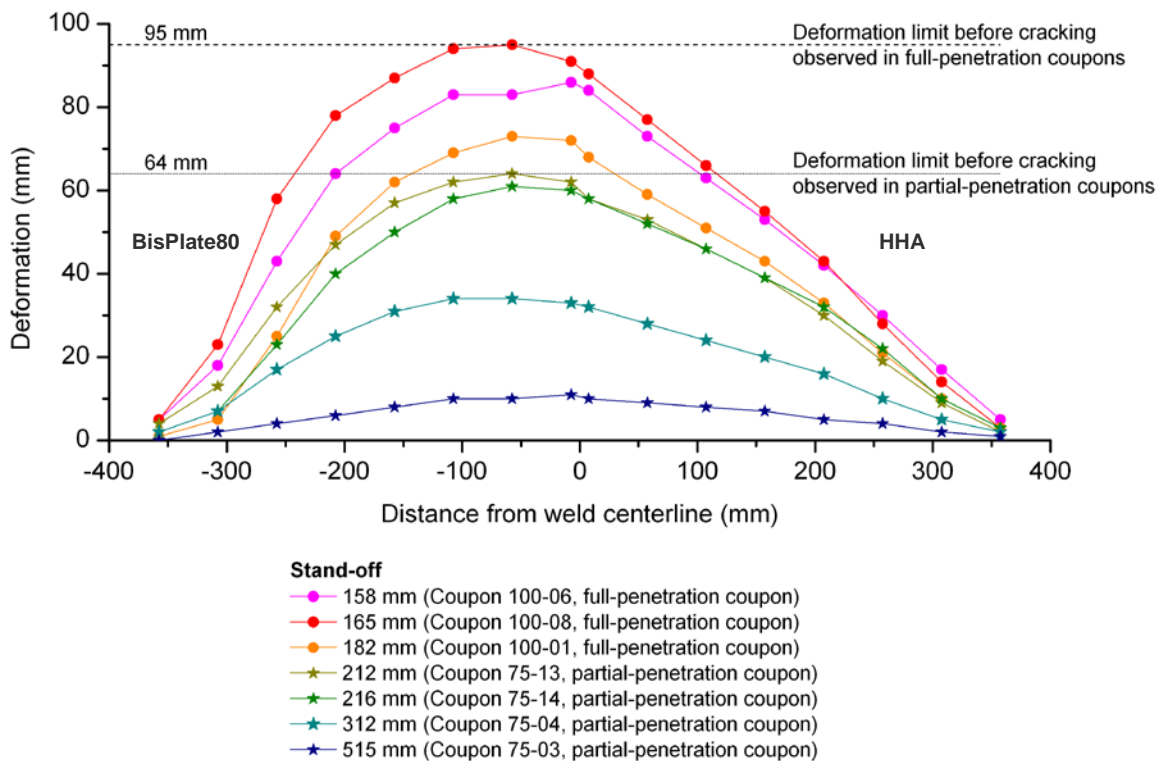
Figure 13: Centreline deformation of plates that did not exhibit cracking. The stand-off distance that corresponds to each test is specified in the legend. The negative distances denote BisPlate80 material whereas positive distances are BisPlateHHA; the weld centreline is the zero reference.

Deformation measurements were made of the uncracked coupons across the weld centreline as described in Section 3.2. Figure 13 shows the deformation across the plate revealing the shape of the bulge. The deformation limit before coupon cracking for full-penetration coupons was approximately 31 mm greater than for partial-penetration coupons. This suggests that the full-penetration coupons were able to accommodate 50% more deformation before cracking. It can also be observed that the shape of the deformation is asymmetric with the BisPlate80 material exhibiting a more rounded bulge compared to the BisPlate HHA.

³ The asymmetric nature of the bulge observed in Figure 13 results from the large difference in the strength of the BisPlate80 and the BisPlate HHA.

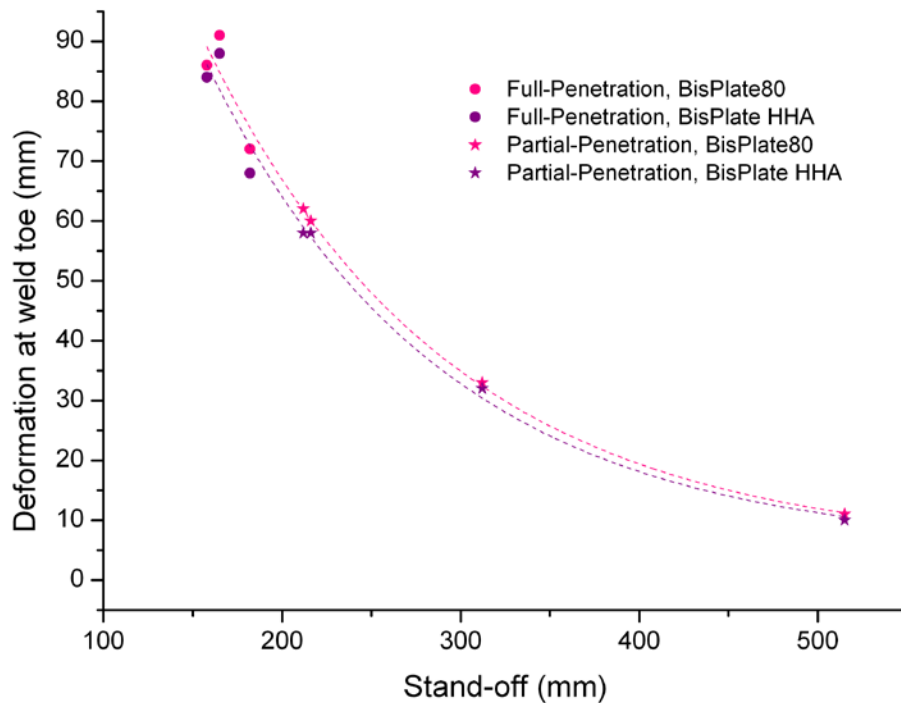
Figure 14: Bisplate80 (pink) and BisPlate HHA (purple) deformation measured at the centre of the un-cracked coupons at the weld toe. Lines have been drawn to guide the eye to the trend in the data.

Figure 14 shows the measured deformation at the weld toe at the centre of the coupon as function of the stand-off, for both the BisPlate80 and the BisPlate HHA material. The plate deformation showed a trend of increasing deformation with decreasing stand-off distance. The results for the full-penetration coupons contain an apparent outlier to this trend (at 165 mm standoff). This is most likely to be an artefact of the deformation measurement technique and will be discussed in Section 6.

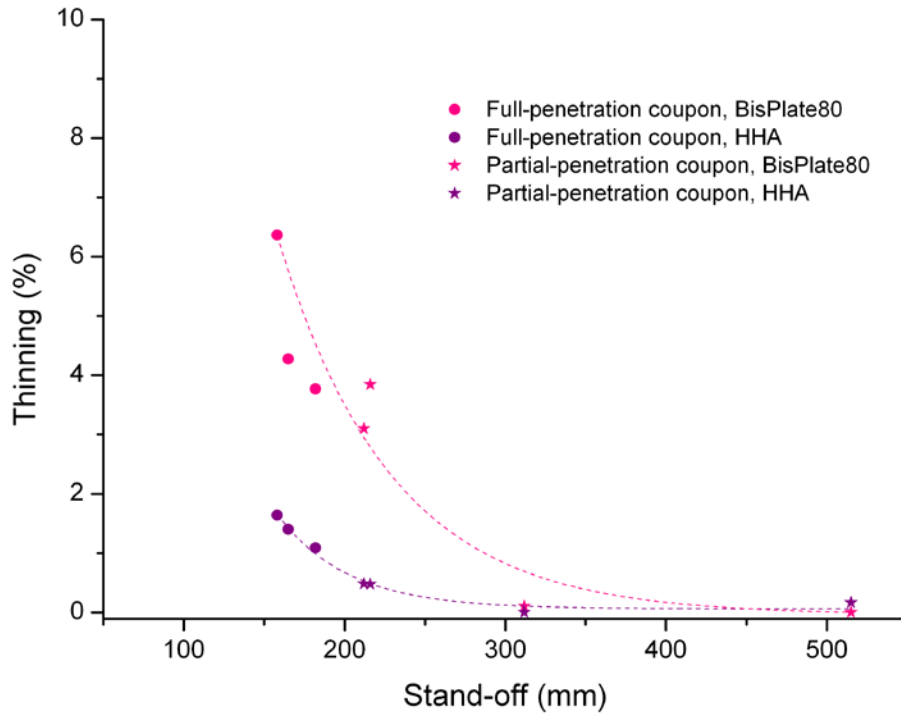
Figure 15: Thinning results from the coupons that did not exhibit cracking. Lines have been drawn to guide the eye to the trend in the data.

Figure 15 shows the thinning that was measured on the full-penetration and partial-penetration coupons which did not exhibit cracking. The BisPlate80 material experienced greater thinning, in all but one test, in comparison to the BisPlate HHA material. The exception occurs when there is almost zero discernable thinning. This exception is most likely a result of the error in the thinning measurements and the variability of the plate thickness. A dashed line has been drawn to guide the eye to the trend where more thinning will occur at smaller charge stand-off distance.

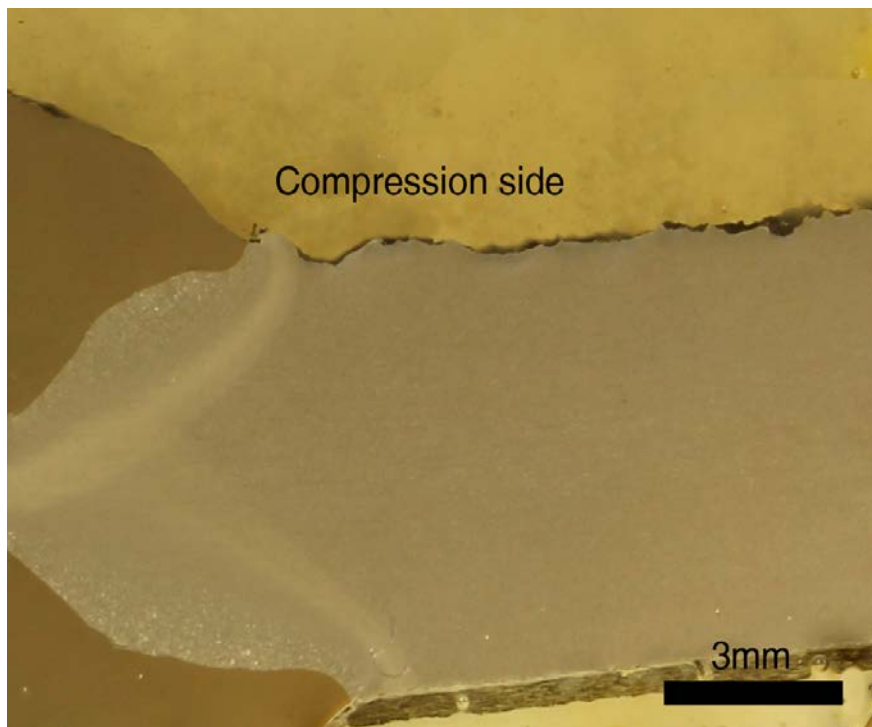
Figure 16: The uneven surface topography on the compression side of plate 100-02

Error in the thinning measurements is always present as a result of the uneven surface topography created by the blast on the compression face of the plate. This is why an average of multiple thinning measurements was generated. The cross-section image of the compression side in Figure 16 shows the surface finish produced by close exposure to the blast. The compression surface is uneven and cratered with thickness variations that can be 0.25 mm or more.

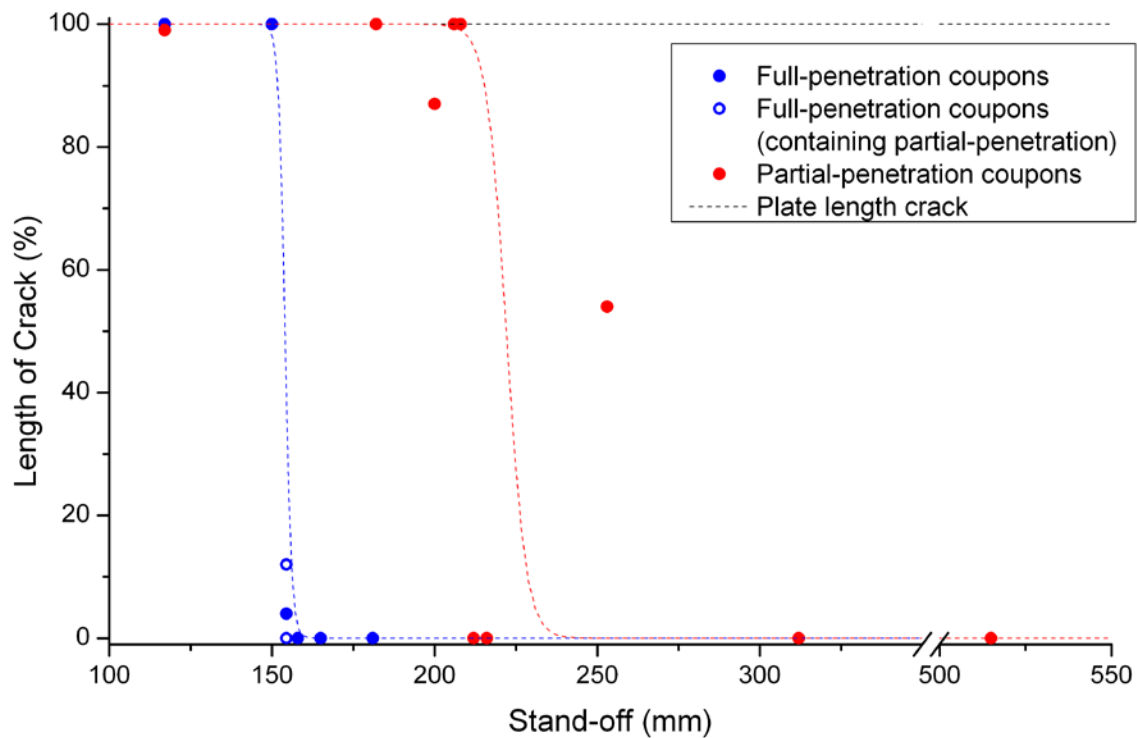
Figure 17: Longitudinal crack length results (expressed as a percentage of the coupon length) for coupons tested at different stand-off distances for the eighteen blast tests. The dashed lines have been drawn to guide the eye to the trends in the coupon behaviour and are not mathematical fits to the data.

Figure 17 shows the length of cracking in the coupon, expressed as a percentage of coupon length, observed as a result of varying the stand-off distance between the charge and the coupon. Coupons 100-02 and 100-04, containing the unintended incomplete penetration defects, have been grouped by colour with the full-penetration data, albeit with an open symbol.

The full-penetration data in Figure 17 shows that there is a distinct threshold stand-off, below which the coupon will exhibit cracking. The partial-penetration data shows a similar threshold, however there is more scatter in the results. Lines have been drawn in Figure 17 to guide the eye to the location of these thresholds but are not mathematical fits to the data. It is evident from these results that the stand-off distance at which failure occurs is greater for the partial-penetration weld condition.

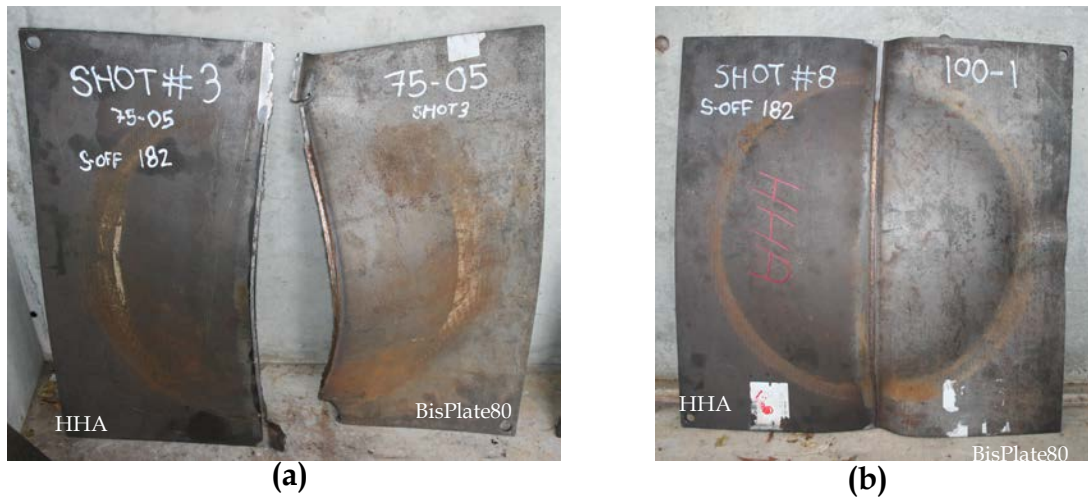
Figure 18: A direct comparison of the blast resistance of; (a) a partial-penetration coupon and (b) a full-penetration coupon, where both were tested at a stand-off distance of 182 mm. The partial-penetration coupon failed completely whereas the full-penetration coupon did not exhibit cracking.

Further illustrating the difference between the two welding conditions is the direct comparison between a partial-penetration coupon (75-05) and a full-penetration coupon (100-01), which were tested at the same stand-off distance of 182 mm (Figure 18). At this stand-off distance the partial-penetration coupon has completely failed through the weld zone, while the full-penetration coupon has deformed without cracking. The full-penetration coupons remained intact until the test stand-off distance was reduced to 154 mm.

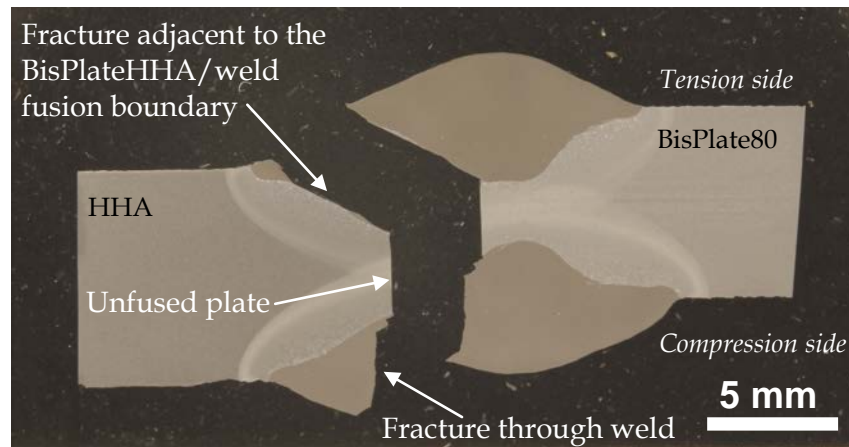
Figure 19: A polished and etched section of a failed partial-penetration coupon (75-12) illustrating the most common crack location configuration.

In the five partial-penetration coupons with cracking solely in the weld zone, the crack location configuration varied from coupon to coupon and along the length of the cracks in individual coupons. The most common crack location configuration, however, was adjacent to the fusion boundary between the BisPlate HHA and the weld on the tension side and through the weld metal on the compression side. Figure 19 is a polished and etched section taken through the fracture surface of coupon 75-12 showing this predominant crack location configuration.

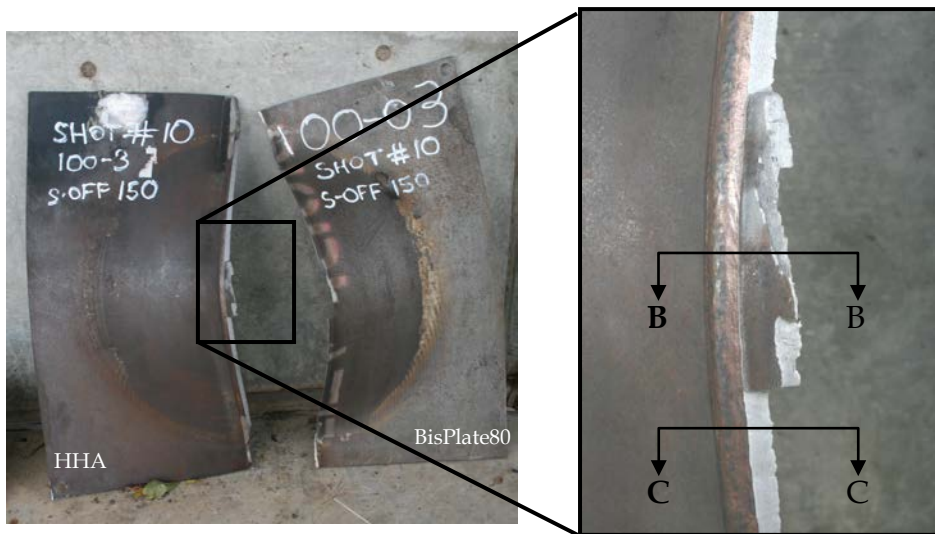
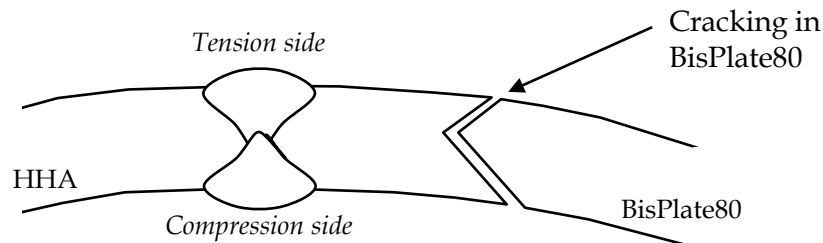
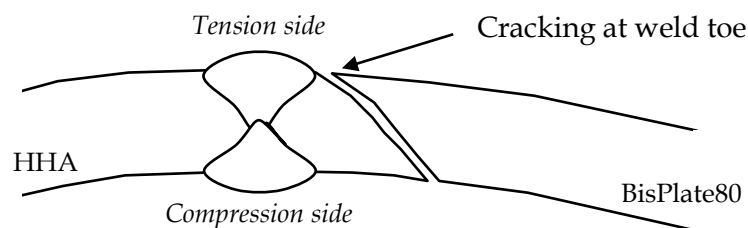
The coupon tested at a stand-off distance of 150 mm, coupon 100-03 shown in Figure 22, showed similar cracking to coupon 100-05, i.e. cracking in the BisPlate80 parent metal near to the apex of the deformation. A sketch of the cross-section of this cracking is shown in Figure 22 (b). Further from the apex, there was additional extensive cracking adjacent to

the weld. The fracture path of this additional cracking extended from the weld toe, in the BisPlate80 on the tension side, through the BisPlate80 at approximately a 45° angle away from the weld, meeting the BisPlate80 plate surface on the compression side, approximately 8 mm from the weld toe. A schematic of this cracking has been included in Figure 22 (c).

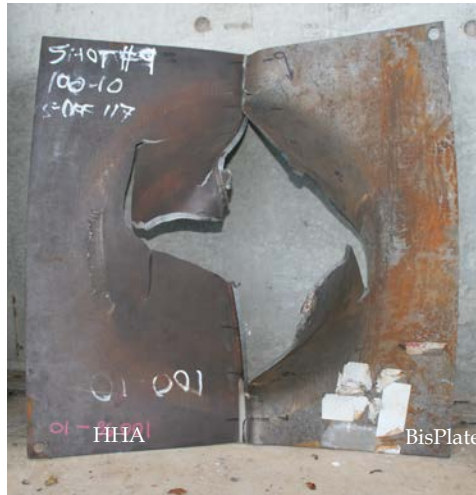
Figure 23: The full-penetration coupon (coupon 100-10) tested at a stand-off distance of 117 mm exhibited cracking in the weld zone and in both plate materials.

The full-penetration coupon tested at a 117 mm stand-off, coupon 100-10, was significantly deformed by the blast and the BisPlate80 and weld toe cracking described above was accompanied by significant cracking into both the BisPlate80 and the BisPlate HHA as

shown in Figure 23. The centre of the coupon tested at a stand-off of 117 mm was so grossly deformed that it came into contact with the floor of the blast chamber.

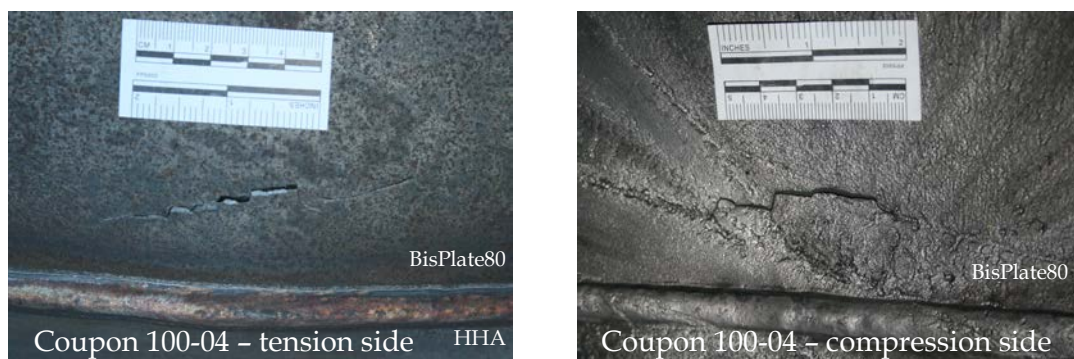
Figure 24: BisPlate80 cracking observed in coupon 100-04 which contains incomplete penetration (90% penetration) and was tested at a stand-off of 154 mm.

The two nominally full-penetration coupons (100-02 and 100-04) containing lengths of incomplete penetration (i.e. 90% penetration) were tested at the greatest stand-off at which cracking was observed in the full-penetration coupons – 154 mm. Cracking was observed in only one of these coupons, Coupon 100-04 shown in Figure 24, which cracked in the BisPlate80 parent metal in a manner similar to the full-penetration coupon tested at the same stand-off, Figure 21.

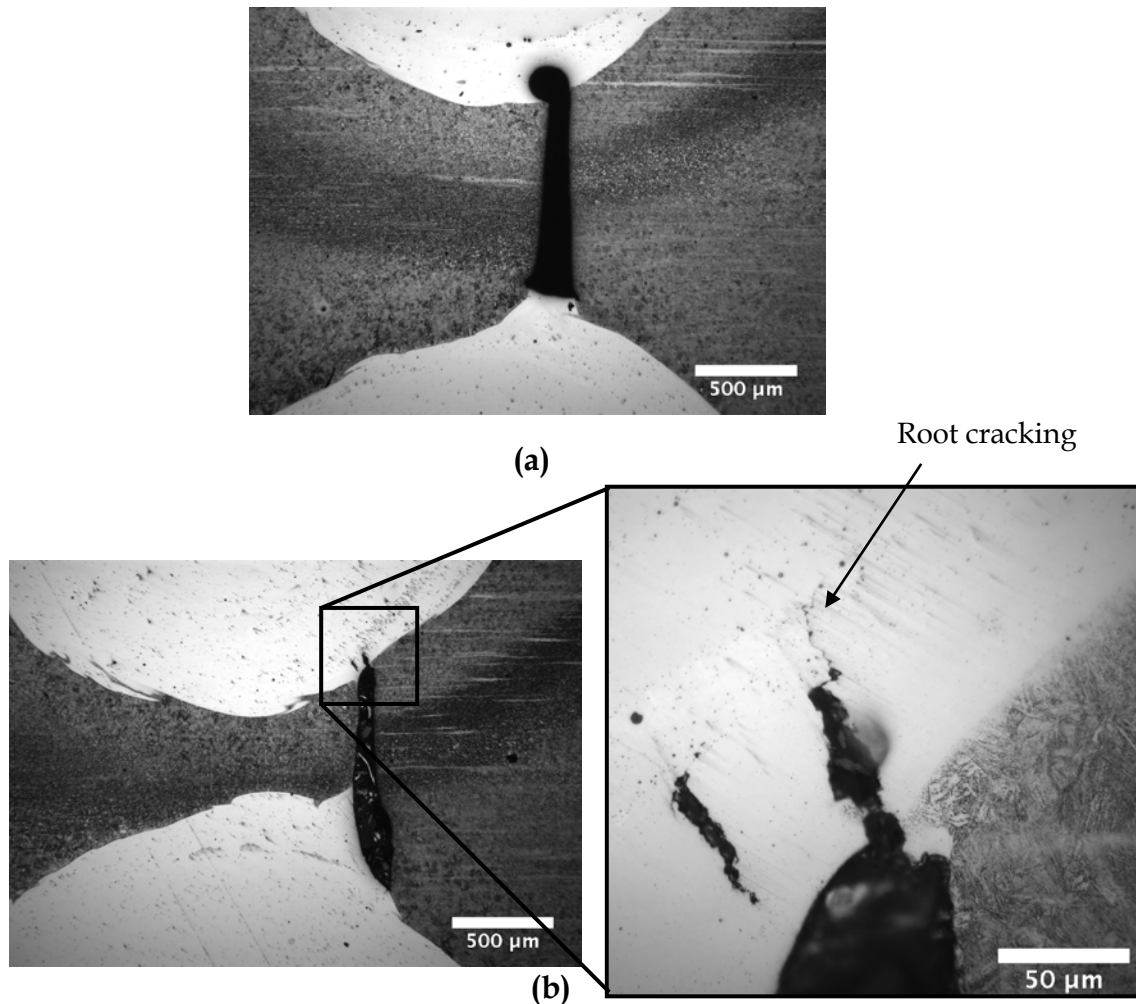
Figure 25: Micrographs of the incomplete penetration (~90% penetration) defects in (a) coupon 100-04 and (b) coupon 100-02.

discontinuity. The incomplete penetration defect in coupon 100-04, shown in Figure 25 (a), does not show evidence of crack growth resulting from the blast.

The incomplete penetration defect in coupon 100-02, shown in Figure 25 (b), demonstrates some evidence of cracking at the end of the incomplete penetration defect. However, it is not clear whether this defect has extended as a result of the blast or whether it is a solidification crack which occurred at the time of welding. In either case the crack is inconsequential in the context of the current study.

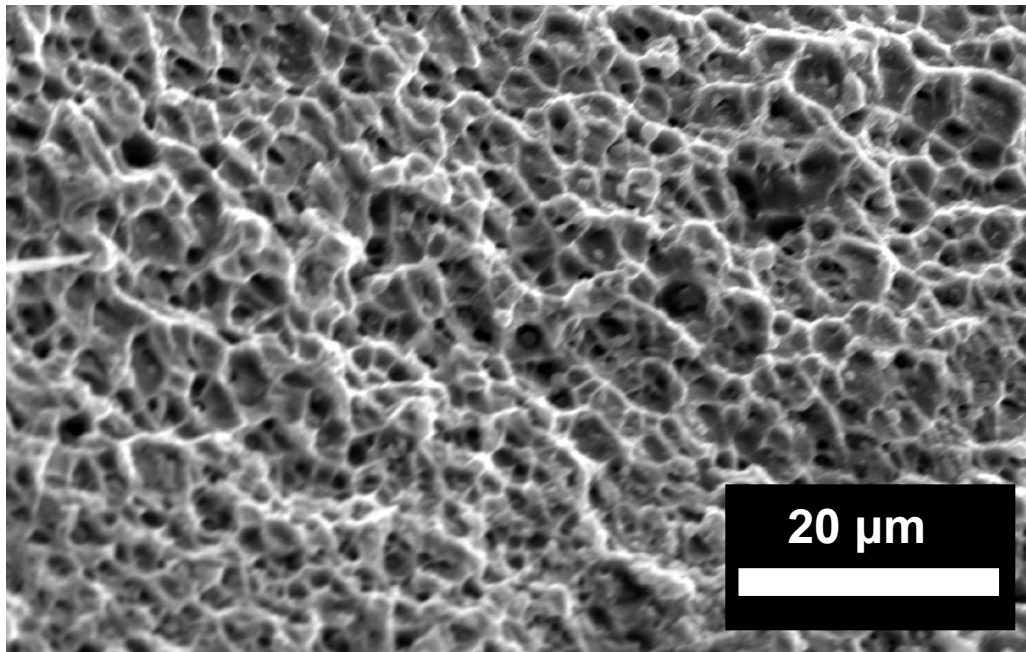
Figure 26: Scanning electron microscope images of ductility on the fracture surface of the tension side crack which propagated through the weld metal (coupon 75-12).

The fracture characteristics of the tension side cracking through the plate material and the weld metal of coupon 75-12 are shown in Figure 26 and Figure 27, respectively. Both images show evidence of ductile fracture and were representative of the majority of the

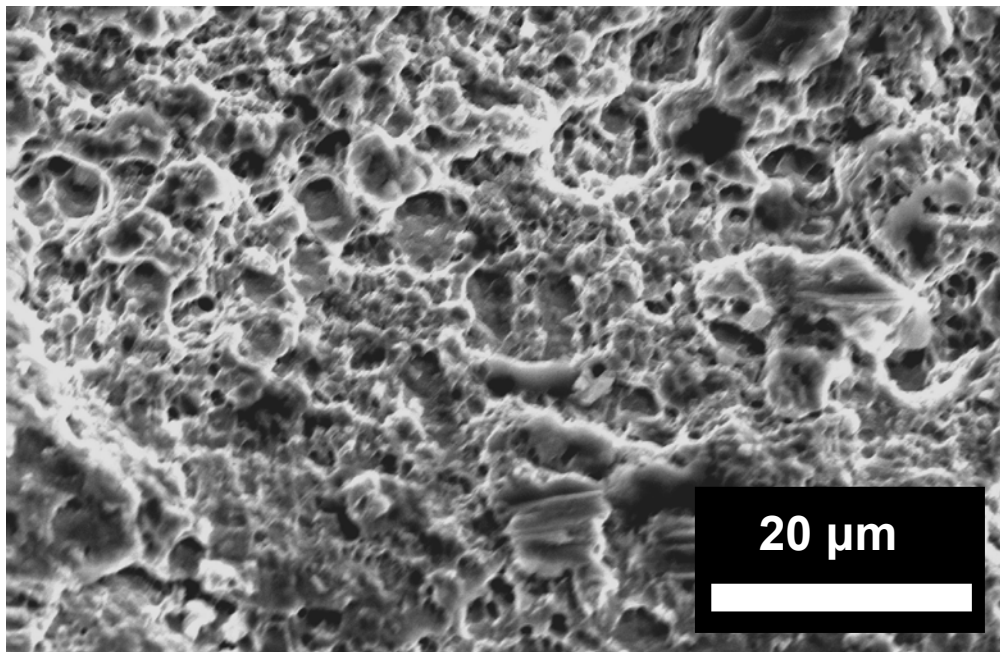
Figure 27: Ductile features on the fracture surface of the tension side crack which propagated through the BisPlate80 material of coupon 75-12. Some smearing damage has occurred after crack formation.

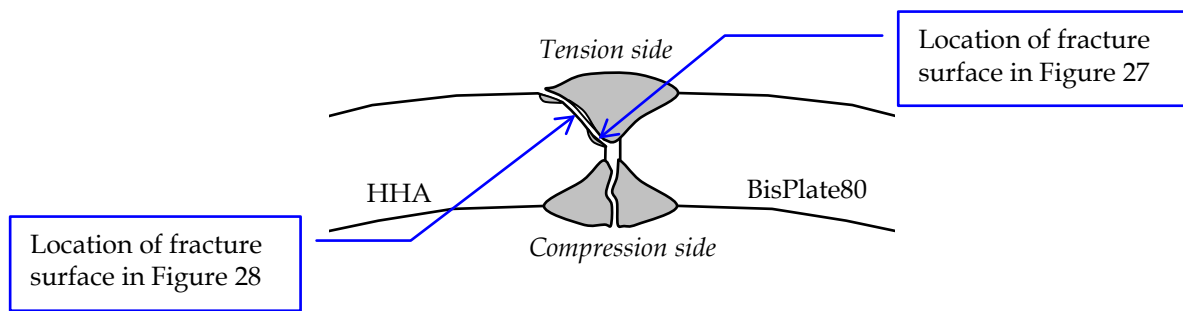
Figure 28: Diagram of the fracture path of coupon 75-12 showing the location where fracture surface imagery was taken using the scanning electron microscope.

fracture surfaces. The coupon 75-12 fracture path diagram, shown in Figure 28, indicates the locations where these images were taken.

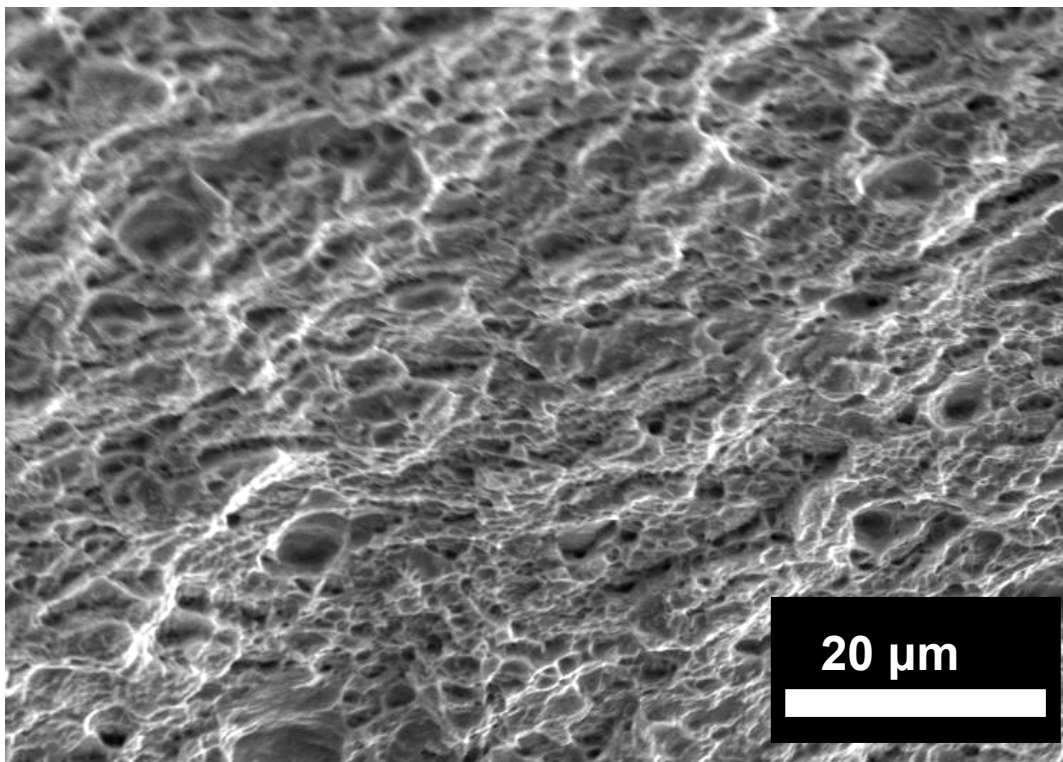
Figure 29: Ductile features on the fracture surface of the crack in the BisPlate80 plate of coupon 100-04.

Cracking in the full-penetration coupons was observed to initiate in the BisPlate80 approximately 20 mm from weld toe (this is outside the HAZ). These cracks were at a 45° angle to the plate surface and necking was observed near the fracture. Figure 29 is a scanning electron microscope image taken of the fracture surface of the crack in coupon 100-04 illustrating the ductile nature of the fracture.
